SEISMIC PERFORMANCE OF PALLET RACKING SYSTEM WITH FRICTION SLIPPER BASEPLATES IN CROSS-AISLE DIRECTION

Zhenghao Tang^{ac}, James R. Maguire^b, Lip H. Teh^b and G. Charles Clifton^c

^a Dexion New Zealand,
e-mails: Zhenghao.tang@dexion.co.nz

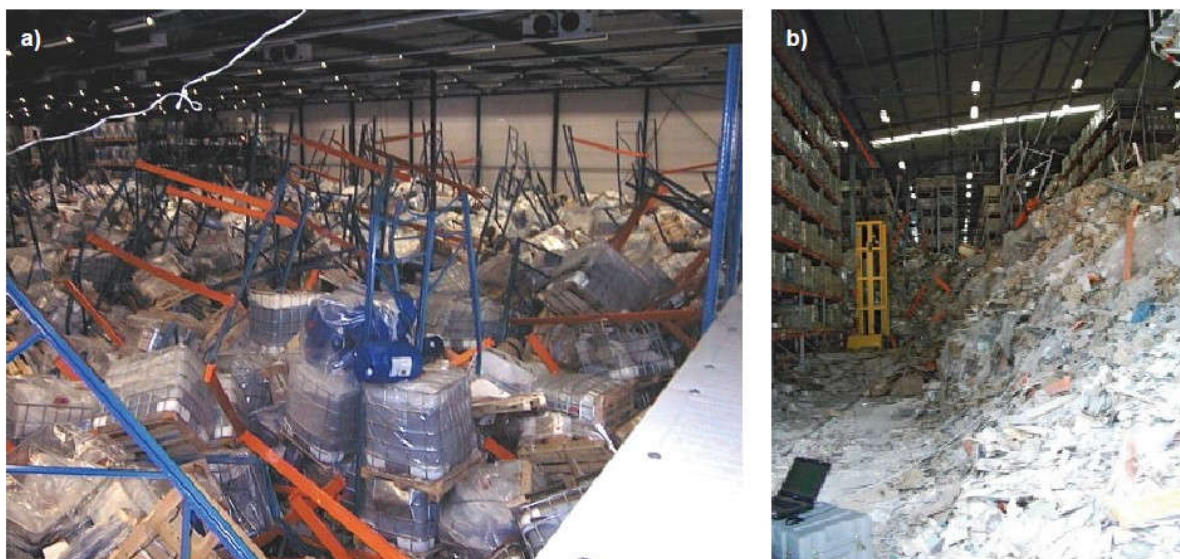
Figure 1: A minor collision can result in total collapse due to the dynamics of pallets falling

Recent earthquake events have shown examples where storage racking systems inside steel buildings of similar age suffered severe damage, while the buildings themselves remained undamaged [1]. Often, a minor collision with a rack can lead to the total collapse of the rack system due to the dynamics of falling pallets. In such cases, a single rack frame collapse may trigger a domino effect, causing adjacent racks to collapse and resulting in the failure of racks throughout the warehouse, as depicted in Figure 1. Several past earthquakes, including the 1987 Edgumbe Earthquake, the 2001 Nisqually Earthquake, the 2010 Darfield Earthquake, and the 2011 Lyttleton Earthquake, have resulted in significant economic losses due to the collapse of pallet racks and loss of contents [2][3][4]. Consequently, seismic resilience has become a critical consideration in the design of racking systems.

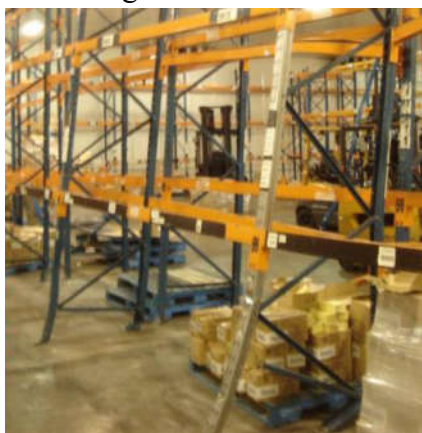
Figure 2: Cross-aisle direction failure by column buckling [3]

The most commonly observed collapse modes of racking systems in the cross-aisle direction during earthquakes are: (a) collapse caused by upright buckling under high compression force, as shown in Figure 2 and Figure 3; (b) overturning due to large tension force in uprights, insufficient ground anchoring, or poor weld quality between the baseplates and the uprights, as shown in Figure 4.

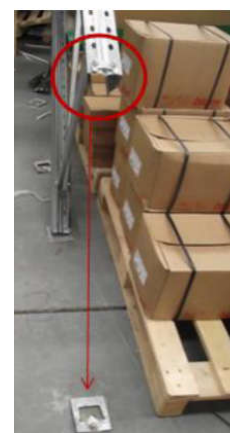
Figure 4: Fracture of baseplate connection [4]

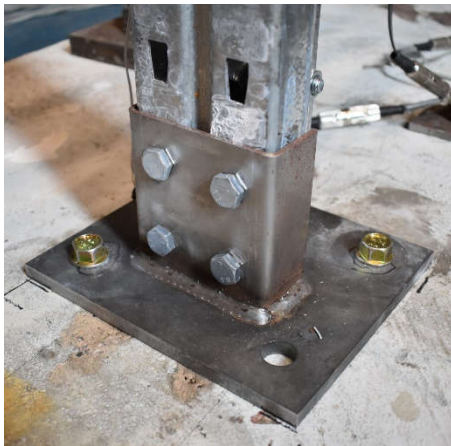
a) Rigid Baseplate

I: Rigid baseplate (RBP), this type of baseplates are widely used throughout the world, which does not allow uplift, as shown in Figure 6a. This typical rigid baseplate is made from a 10-mm-thick steel floor plate with a 4-mm-thick vertical stub that fixed to the upright with 4 pieces of M8 bolts. This type of base connection has almost no energy dissipation capacity.

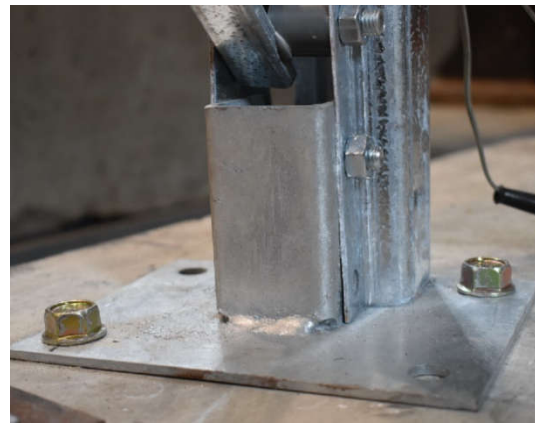
b) Ductile yielding baseplate

II: Ductile Yielding baseplate (DBP), which allows the frame to uplift at the base and dissipate energy through steel plate yielding, as shown in Figure 6b. This baseplate is made from 3.5-mm-thick ductile steel. With further increment of the axial load, the Ductile baseplate will dissipate seismic energy through developing its uplift and metal plate yielding.

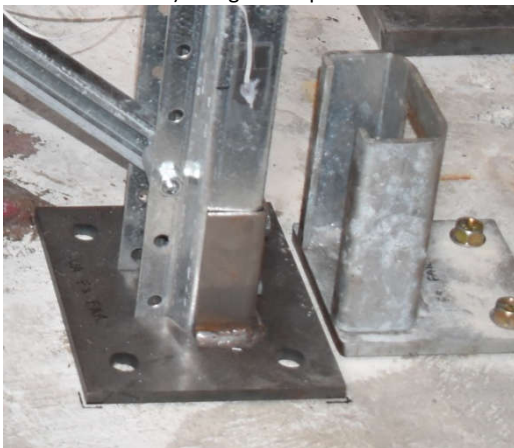
c) Unanchored Baseplate

III: Unanchored baseplate (UBP), as shown in Figure 6c, which can be consider as a free-to-rock base with horizontal shear resistance. Since there is not anchored, the energy dissipation through the baseplate is mainly due to the rocking behavior.

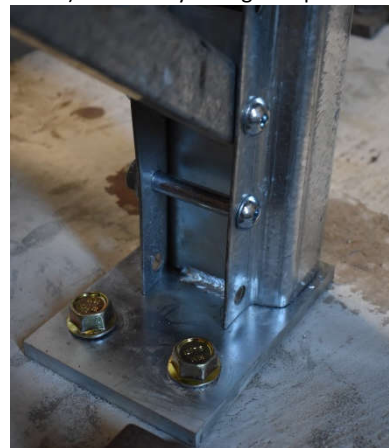
d) Friction Baseplate

IV: Friction baseplate (FBP), as shown in Figure 6d. It dissipates seismic energy through the uplift displacement between uprights and the inner stub with a stable clamping force applied by bolts.

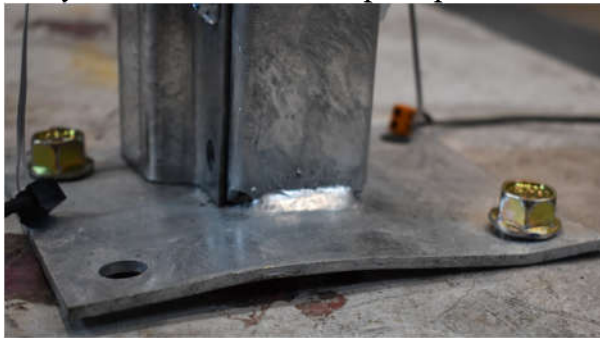
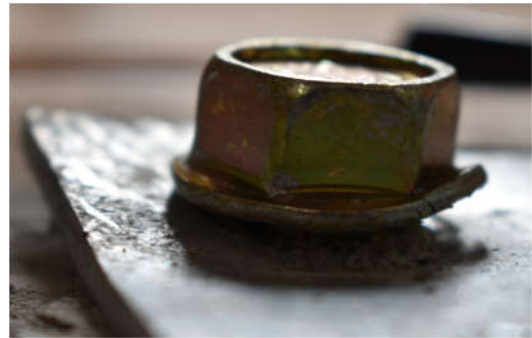
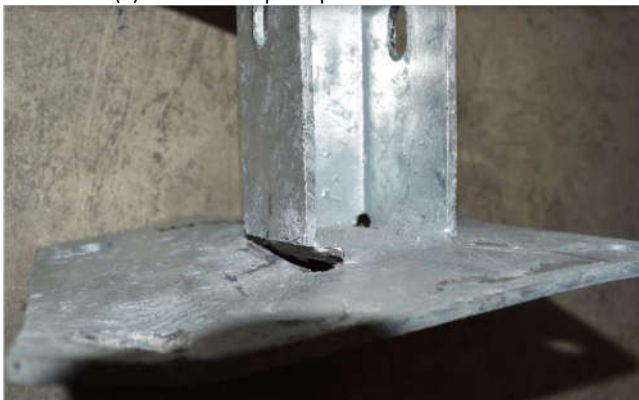
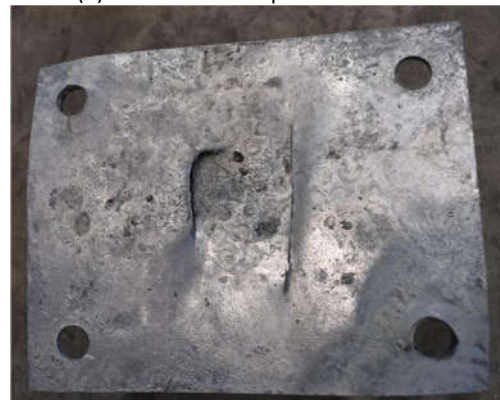
(a) Ductile baseplate permanent deformed

(b) Bolt loosened & pulled out a little

(c) Ductile baseplate fracture at welding

(d) Fracture through the floor plate

Figure 8: Ductile yielding baseplate damage after all 12 ground motions

The observed damage was primarily concentrated at the baseplate-floor connection. Starting from 1.25 times the design level ground motion, slight permanent bends were evident in the floor plates. Additionally, some uprights exhibited localized twisting or bending, measuring 1-2 mm relative to the floor plates. As the ground motion intensity reached 1.5 times the design level, cracks were observed at the corners of the welds between the stub and the floor plates. As the ground motion intensity increased further, the bending of the floor plates, twisting between uprights and baseplates, and fractures at the welds continued to develop, leading to an accumulation of damage. Following the completion of all 12 ground motions, the floor plates showed extensive yielding and upward bending, as depicted in Figure 8 (a). Many floor plates were torn off at the weld connection to the stub, and some fractures were observed to penetrate through the floor plates, as shown in Figure 8 (c) and (d). In certain cases, the anchor bolts experienced minor pull-out, with a few millimeters of displacement, as shown in Figure 8 (b), but they did not lose their complete pull-out resistance.

The rack with the Ductile baseplate exhibited behavior of a free rocking frame with a hook element. The uprights forcefully impacted the floor and rotated around the upright base until restrained on the other side by the baseplate anchored to the floor. By the conclusion of the test, most of the baseplates were fractured, as illustrated in Figure 8. Due to the yielding and fracturing of the steel plate, a substantial amount of seismic energy was dissipated by the baseplate, thereby preventing the overturning and collapse of the rack frame up to 2.3 times the design level. Although this performance surpasses that of the rack with a rigid baseplate, it is important to note that, in the aftermath of a severe earthquake event, the replacement of the baseplate can incur significant time and financial costs, potentially leading to business disruptions. An even better performance was observed with the friction slipper baseplate.

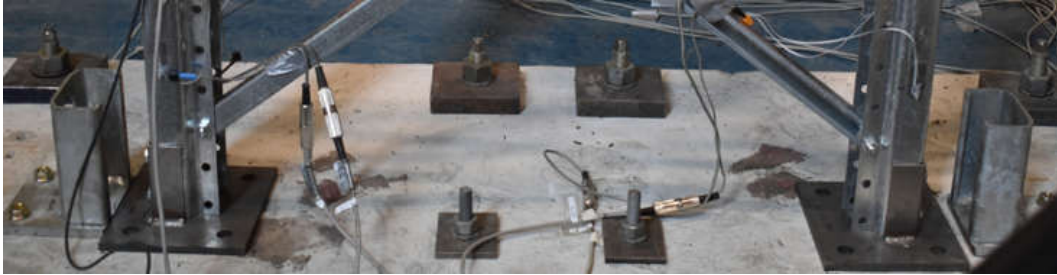
Figure 9: Unanchored baseplate: Restraining cross-aisle movement while allowing frame uplift

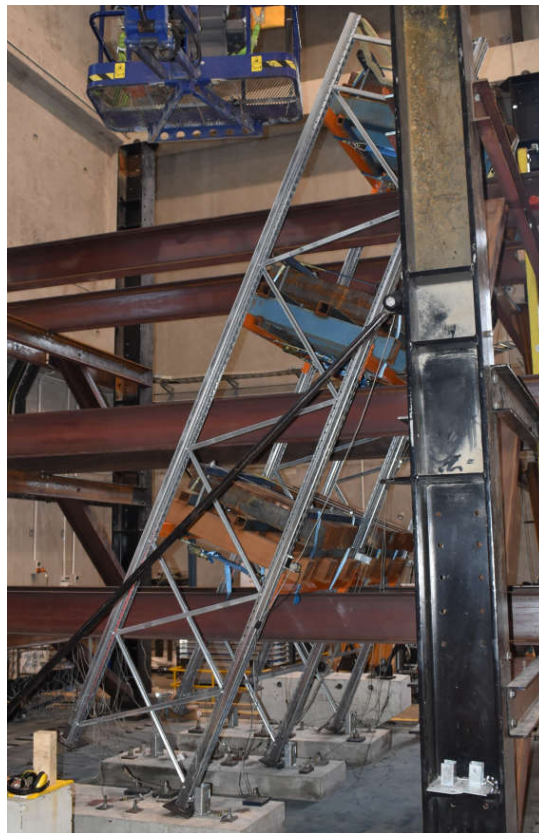
Figure 10: Unanchored baseplate frame overturned at design level 1.5x Northridge earthquake

After successfully surviving all four gradually increased intensity Kaikoura Earthquake ground motions, as well as the first two Northridge and first two Kobe Earthquakes, the rack overturned during the 3rd Northridge ground motion, which was at 1.5 times the design level earthquake, as shown in Figure 10.

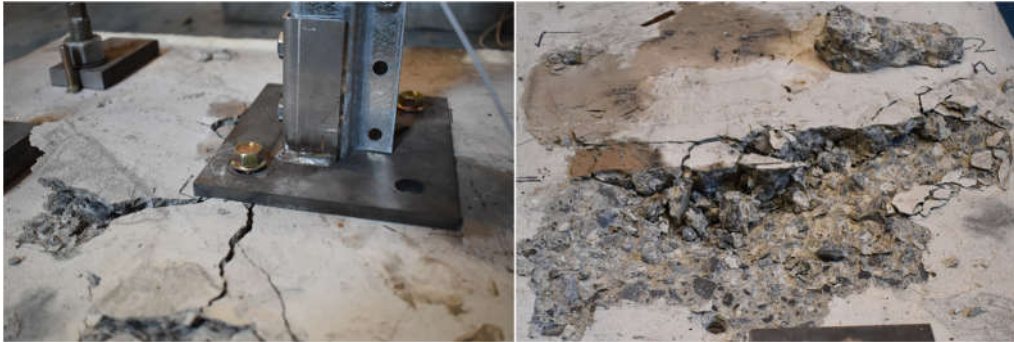
Figure 11: Rigid baseplate anchor bolt pulled out

The rack frame with a rigid baseplate survived the first 7 ground motions, up to 1.25 times the design level earthquake, without any noticeable damage. However, during the 8th ground motion, which was at 1.5 times the design level earthquake (Kobe Earthquake), the anchor bolts into the concrete were pulled out due to the very large pull-up force at the upright and baseplate connection. As a result, the concrete slab around the baseplate area was destroyed, as illustrated in Figure 11, down to the full depth of the anchor bolt (80 mm depth). Subsequently, the damaged slab was replaced with a new concrete foundation slab for the remaining tests.

The rack with the Rigid baseplate shows the largest axial load compared to all other baseplate cases and failed at 1.5X design level by anchor bolt pull-out off concrete slab. During an earthquake event, the earthquake-induced energy will accumulate in the structure with a limited dissipation pathway, primarily converting between kinetic energy and potential energy. As the total energy in the system increases, the internal force also escalates until one or more structural members experience failure. This phenomenon was confirmed by this shaking table test.
