RETROFIT METHOD FOR REPAIR OF CORRODED BOLTED CONNECTION

Keywords: Bolted Connection; Corrosion; Retrofit; Connector Element.

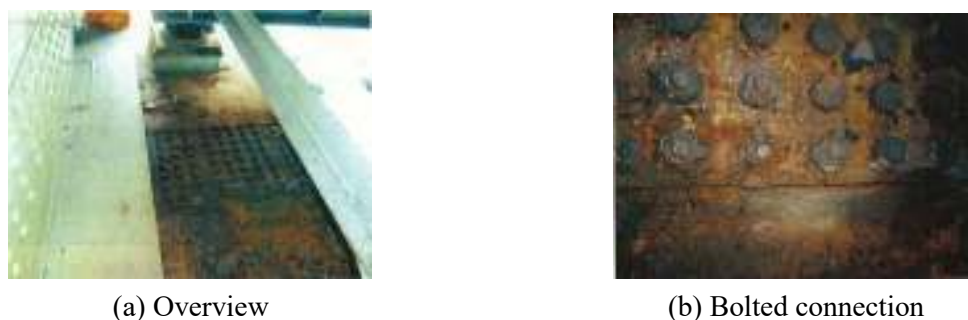
Figure 1: Corroded bolted connection.

One of the most critical phenomena that could control the service life of a steel bridge is corrosion. Because of the complexity of its geometry, the quality of painting tends to be lower in a bolted connection than that in any other part of a steel bridge and water tends to be stuck in a bolted connection. As a result, a bolted connection is often found severely corroded. An example is given in Figure 1. It was located on the top flange of the beam in a steel moment frame supporting expressway. There seemed water leakage at the end of the girder that led to the corrosion.

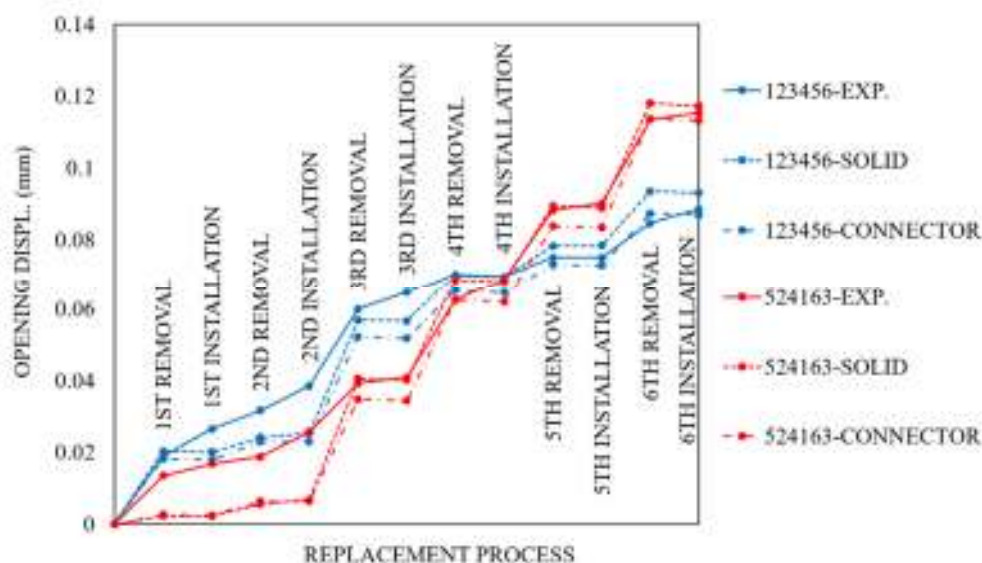
Figure 4: Opening displacement

The numerical results are presented in Figure 4. The blue dotted line is the opening displacement by the 3-D solid elements for Pattern 123456. It can be seen that the opening displacement increases with the bolt replacement. The blue dashed line is the opening displacement by the connector element analysis for Pattern 123456. It captures the same tendency in the opening-displacement variation. The two lines indicate that the difference between the results of the two analyses appears quite small.

The red dotted line is the opening displacement by the 3-D solid elements for Pattern 524163. The opening displacement increases with the bolt replacement also in this replacement pattern. To be interesting, the way the opening displacement varies is different from that of Pattern 123456: initially the opening displacement is smaller than that of Pattern 123456, but it becomes larger at the end. The importance of the repair order is recognized.

The red dashed line is the opening displacement by the connector element analysis for Pattern 524163. It captures the same tendency in the opening-displacement variation, and in fact the difference between the results of the two analyses is again insignificant.

To see the validity of the present numerical approach, experiment is conducted (Figure 5). For each bolt-replacement pattern, three specimens are tested. The average of the experimental results is shown in Figure 4 by solid lines. In the beginning when the opening displacement is small, the experimental results are larger than the numerical results in both of the bolt-replacement patterns, yet the difference decreases as the bolt-replacement progresses and the opening displacement increases. The same tendency as that of the numerical results is observed in the experiment: Initially the opening displacement of Pattern 123456 is larger, but that of Pattern 524163 becomes larger at the end.

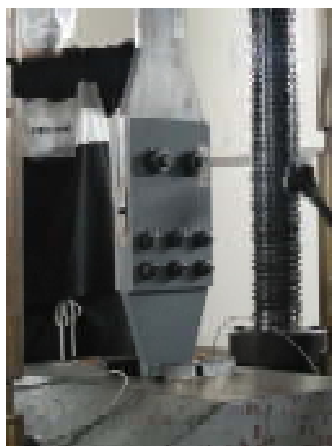
Figure 5: Experiment.

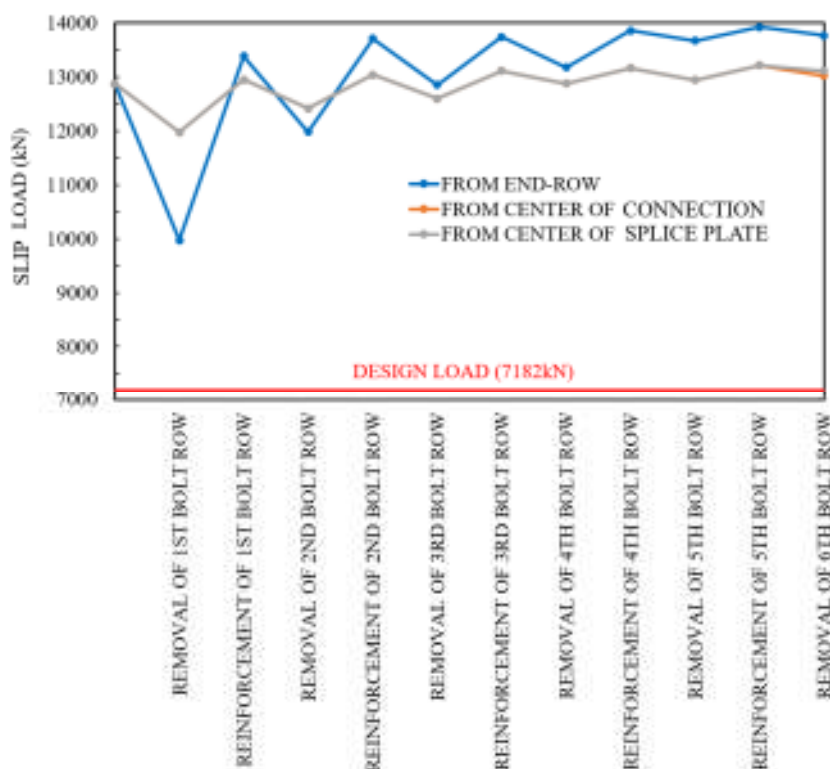
Figure 8: Slip loads.

Figure 8 shows the slip loads. The retrofit processes of Patterns (b) and (c) are exactly the same up to the reinforcement of the 5th bolt row. The slip load is small when the bolts in the 1st bolt row are removed in each pattern. The smallest slip load is observed in Pattern (a). The difference between Pattern (b) and (c) appears at the removal of the bolts in the 6th bolt row, and the slip load of Pattern (b) is smaller. The best repair procedure of the three is therefore Pattern (c). The result here indicates that it is better the repair is carried out near the center of a connection and near the center of a splice.
